Village of River Forest
(2) Concrete Water Reservoir Rehabilitation

January 5, 2026
Addendum No. 1

Attached are Drawings 01 and 02 for the project and the photo album for the 2,000,000 reservoir.

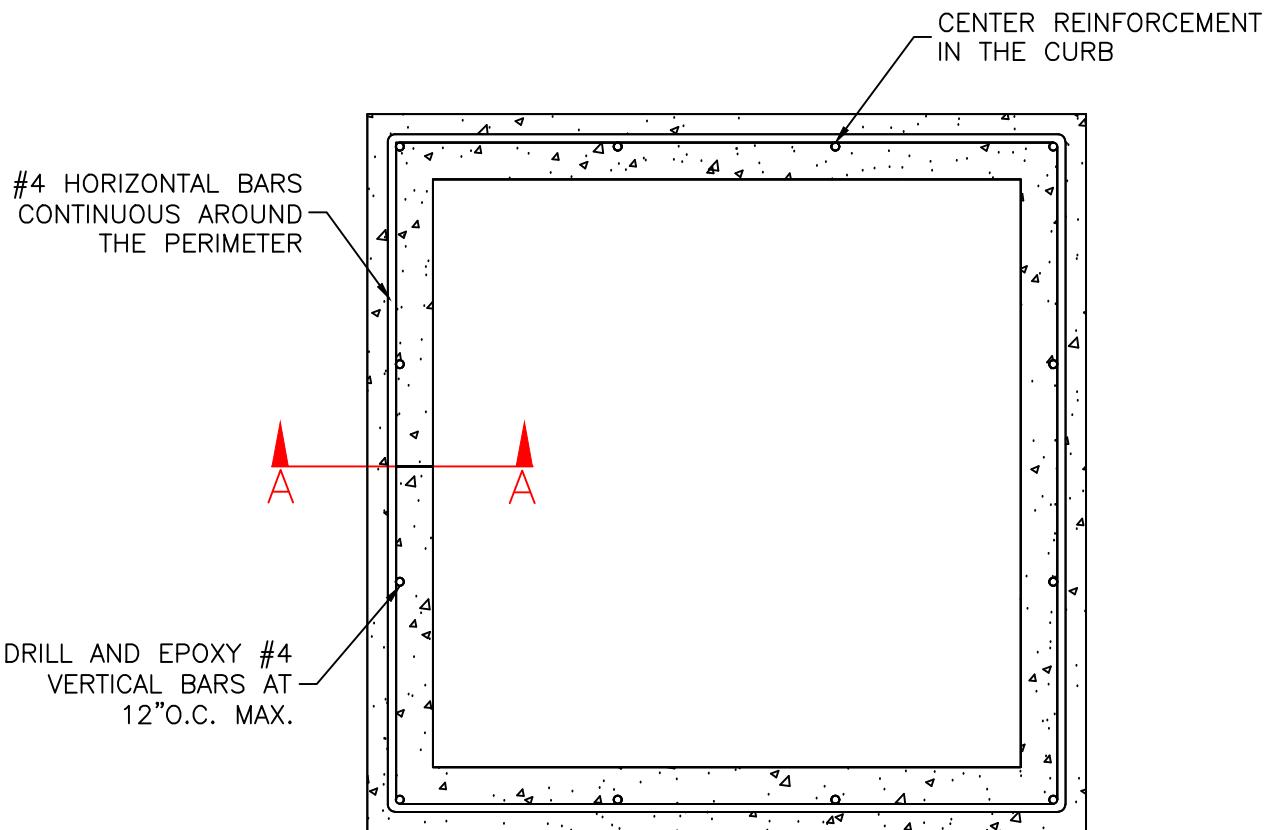
PLAN VIEW

1. THE HORIZONTAL #4 BARS ARE TO BE CONTINUOUS AND WRAP AROUND CORNERS, LAP SPLICES SHALL BE A MINIMUM OF 19 INCHES.
2. NUMBER OF BARS REQUIRED MAY DIFFER FROM DRAWING, FOLLOW THE MAXIMUM SPACING REQUIREMENTS.

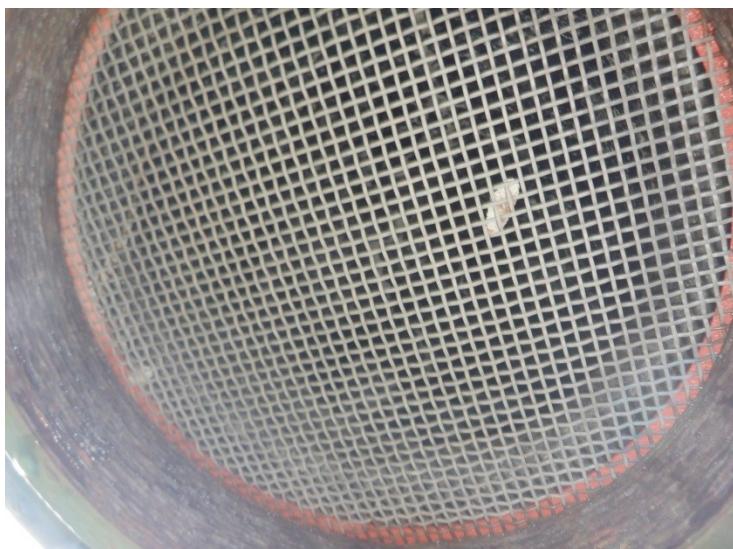
3) The goose neck vent screen is intact but oversized.

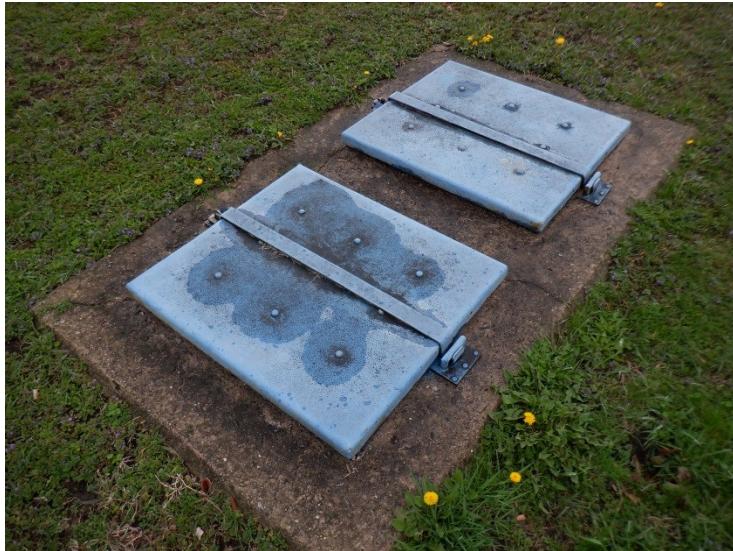
4) The roof hatch curbs do not extend 24 inches above the ground.

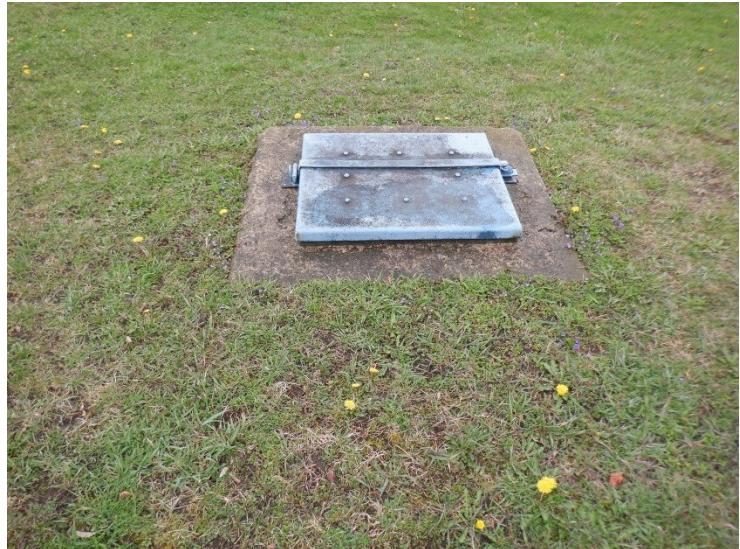
5) Same.

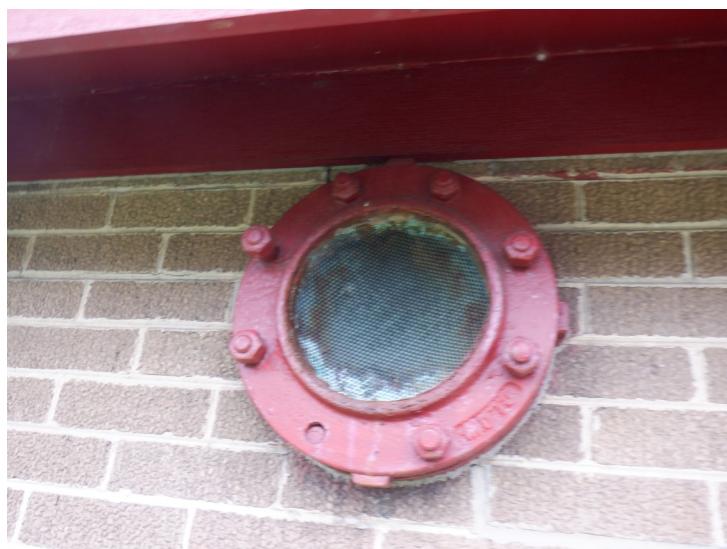
9) The screens are in good condition but oversized.

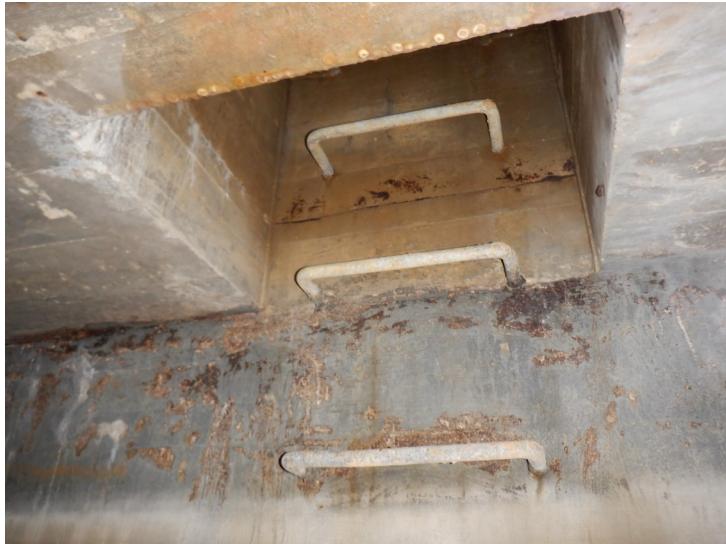
10) The wet interior ladder cleats appear to be in good condition.

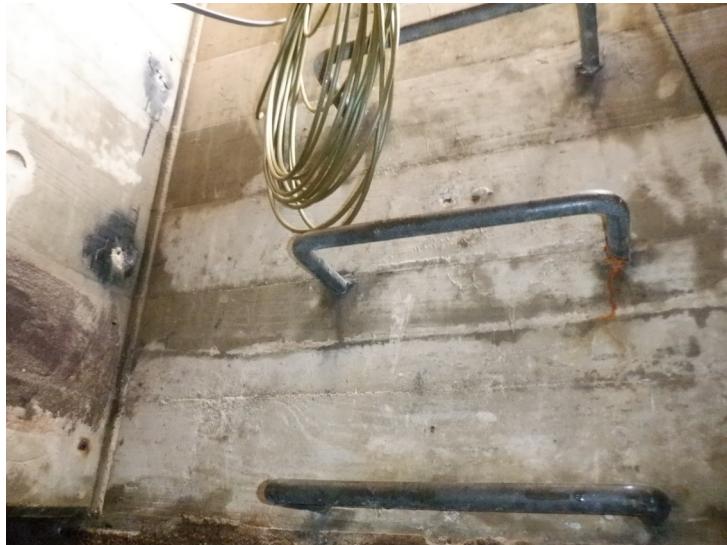
11) Same.

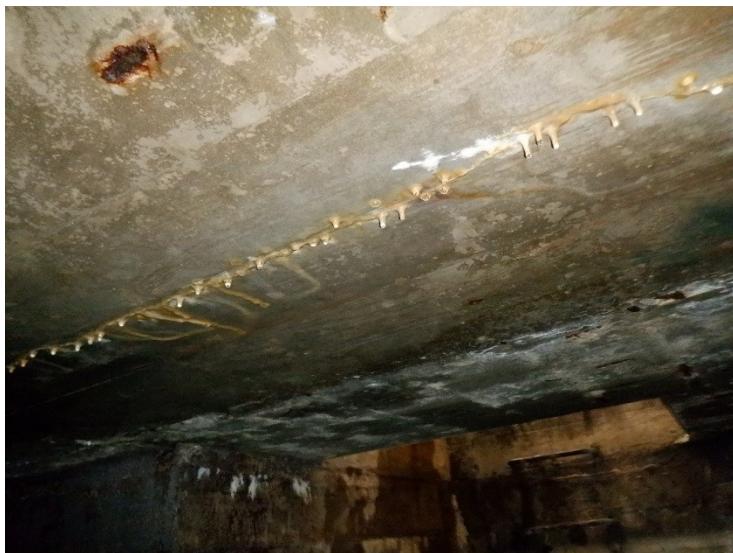
12) There are a few cracks with efflorescence present on the wet interior concrete roof.

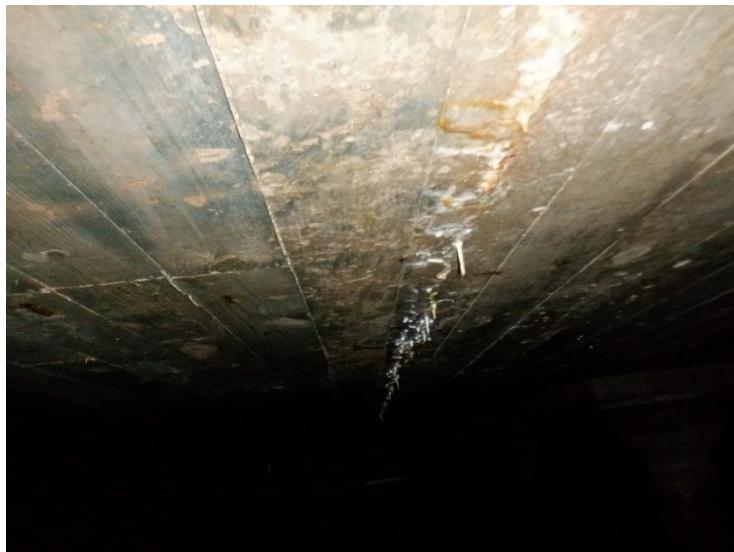
13) Same.

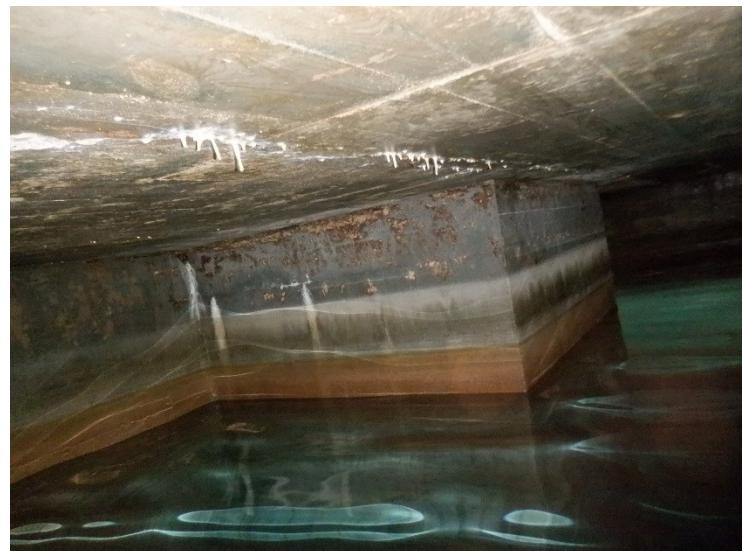
14) Same.

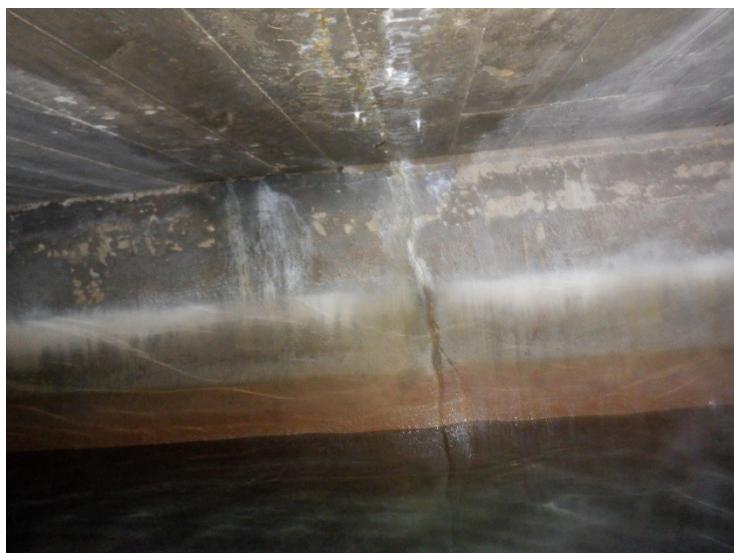
18) There are a few cracks on the wet interior concrete sidewall.

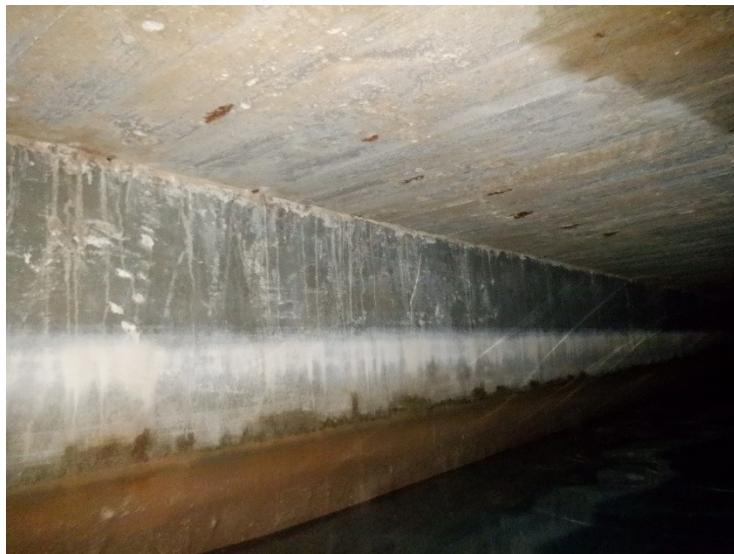
19) Same.

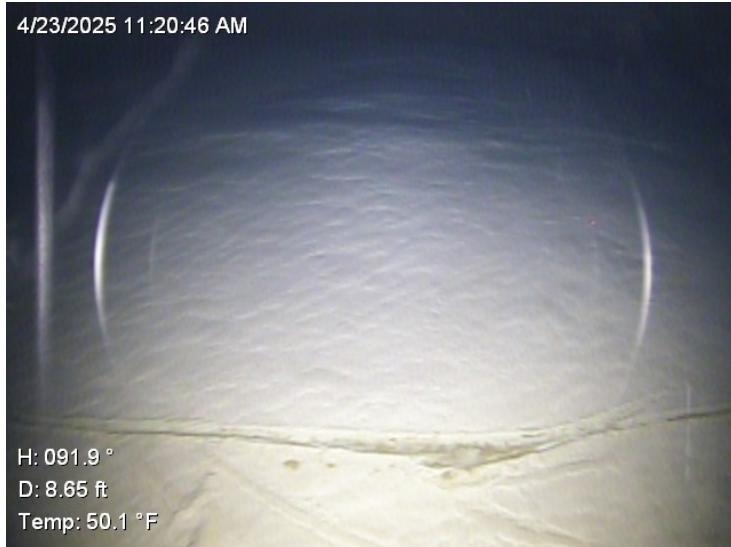
34) The floor is covered with sediment that limited the amount of surface visible with the ROV.

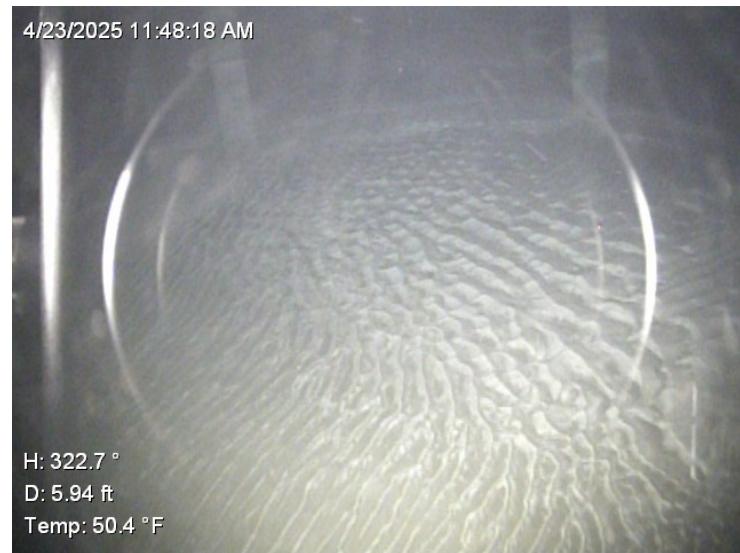
35) Same.

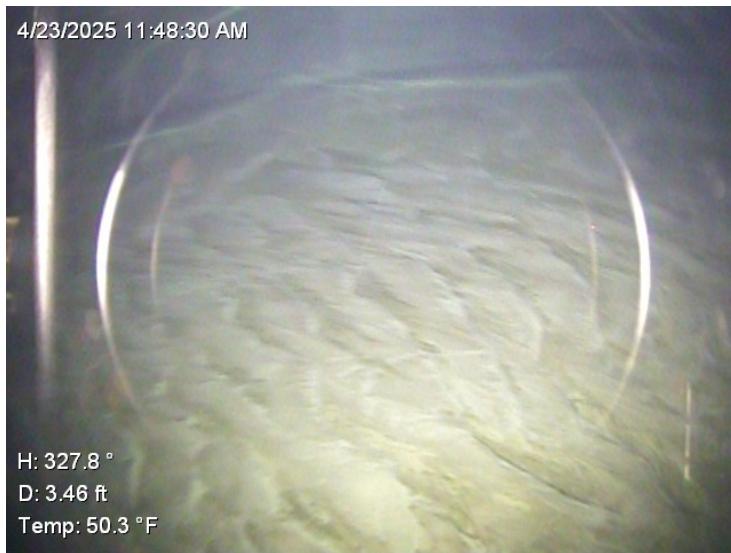
36) Same.

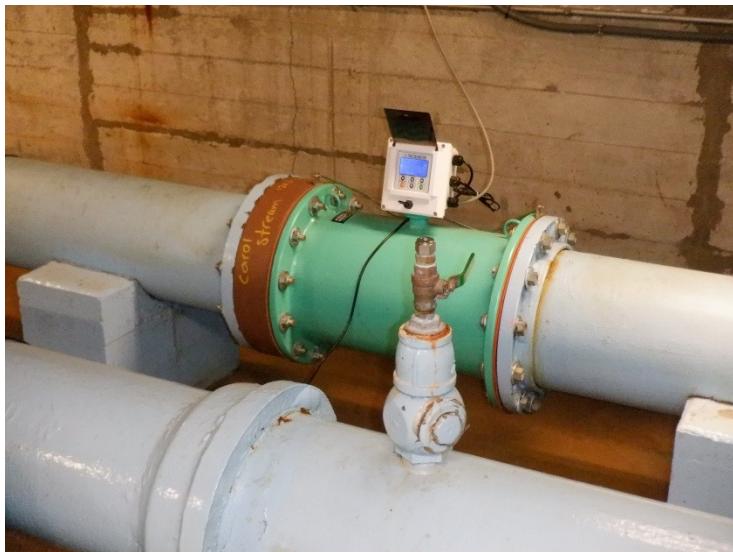
37) The pipe coating in the building is in good condition with minor surface corrosion.

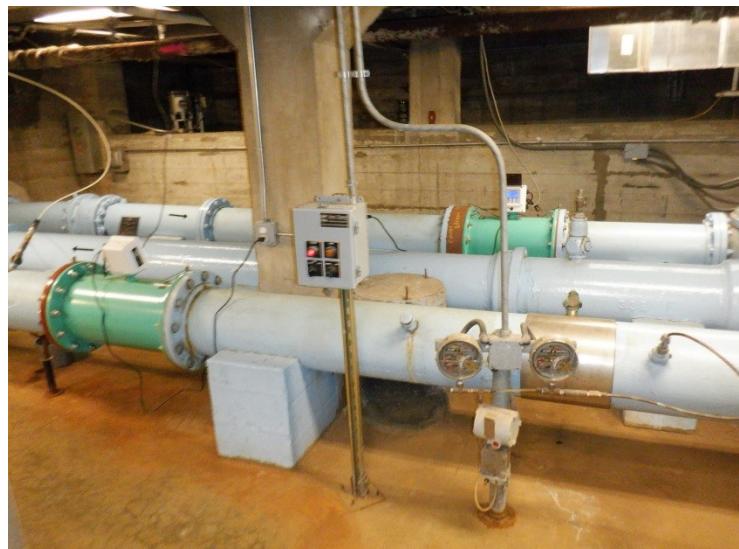
38) Same.
