- I. Call to Order
- II. Public Testimony
- III. PUBLIC HEARING – Application #17-01 - Certificate of Appropriateness application for the DEMOLITION of the single family residence located at 747 William Street, River Forest, IL, a structure listed on the Village survey of architecturally or historically significant properties.

Re: 747 William Ave.

At the request of the Historic Preservation Commission, I am providing the following structural assessment of the existing single family residential building located at 747 William Avenue. Mr. Rob Sarvis, the owner of the building, asked me to provide this information to the Commission.

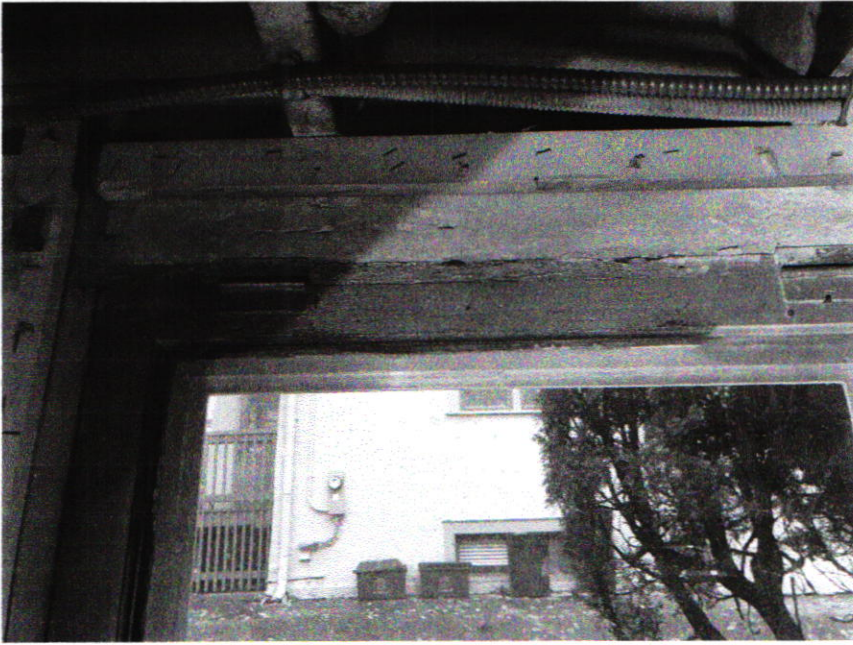
The existing building has an 8" wide concrete block foundation wall which is approximately 52" high from the basement floor to the top of the wall, with a 2 x 4 wood stud wall on top of the block extending upwards. While there are no openings where I can visually see the exterior wall framing above the first floor, I strongly suspect that the exterior walls are balloon-framed, which would have been standard construction practice at the time this building would have been constructed. Buildings of this era also will only have headers above windows and doors consisting of (2) 2 x 4's laid flat (Photograph #1) which are not adequate for carrying loads above and also will not keep openings square and plumb.

Photograph #1 - (2) flat 2 x 4's used as a header

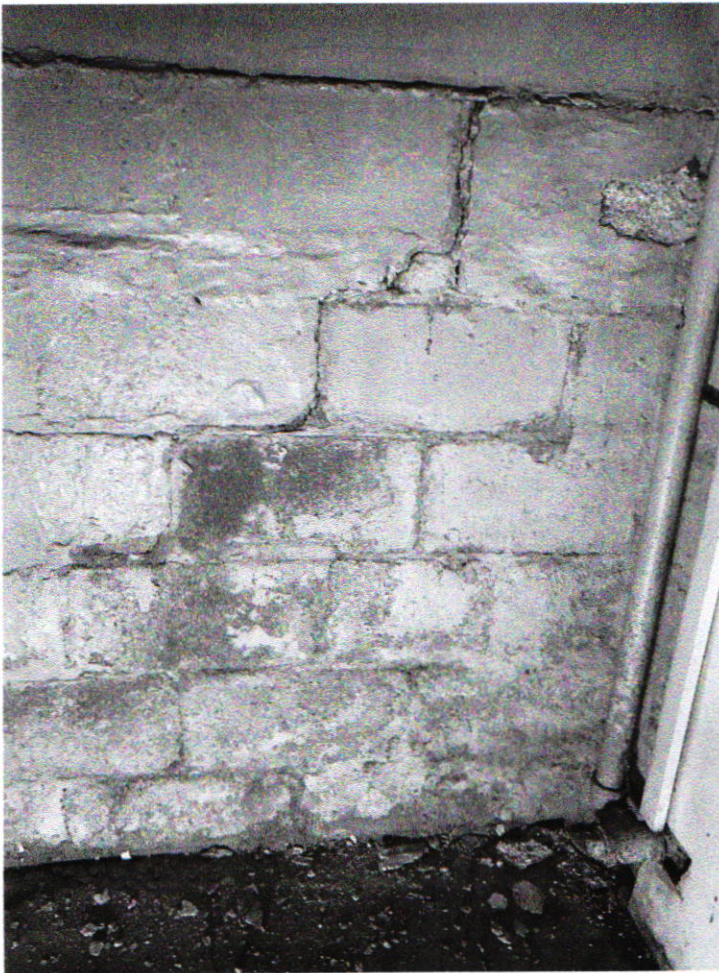
In two locations in the rear of the house, there are significant diagonal cracks in the block wall. Moisture in the wall has eroded the mortar and the joints are opening up. (Photographs #2 and #3) The front half of the basement has been finished with wood furring strips and plywood paneling, so without removing the finish materials in that area, I am unable to

Photograph #2 - Foundation wall crack, southeast corner

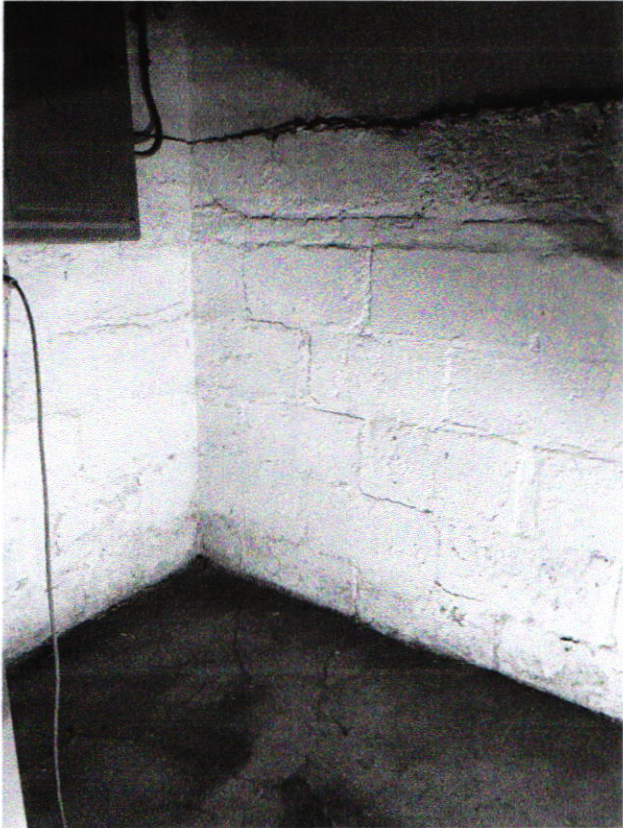
Photograph #3 - Foundation wall crack, east wall

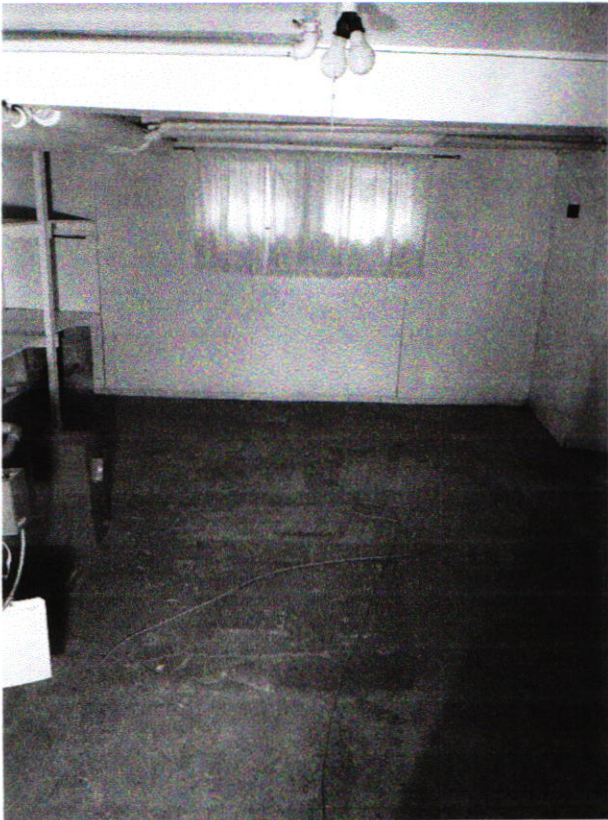
In the front half of the house, an interior column was removed which supported the main center beam. (Photograph #4) In addition, in the crawl space under the front sun porch, the beam is supported by a short jack post resting on wood blocking laid on the dirt floor. (Photograph #5). Note that the post is not located at the location where beams overlap - it is about 18" away. This is causing one part of the beam to sag, which can be seen in Photograph #6. The combination of the missing interior column and the poorly supported sun porch beam has caused the wood knee wall on top of the foundation wall at the west wall of the basement to tip outward approximately 2-1/2" in the 32" of wall height. In both the first floor living room and the second floor bedroom above this part of the house, there is a very significant slope in the floor going downhill to the west of about 2-1/2" to 3". The sloping clearly has occurred due to the shifting of the structure below.

One side note: referring again to Photograph #4, note that the support wall around the crawl space under the porch is brick and not block as is the case with the greater part of the house. This was done at some point later in the life of the home and is not original to the structure. Unless some excavation is done on the outside of this wall, there is no way to know if this was installed down to a supporting foundation depth or just added to keep animals from living under the porch. Given the serious slope in the floor of the sun porch, my suspicion is that the latter of these is likely the case. It is also interesting to note that the insulation that was installed is placed horizontally, not vertically between any type of stud wall framing. That validates that this space must have been open underneath and then infilled later.

Photograph #4 - location where column removed. Pier visible in floor.

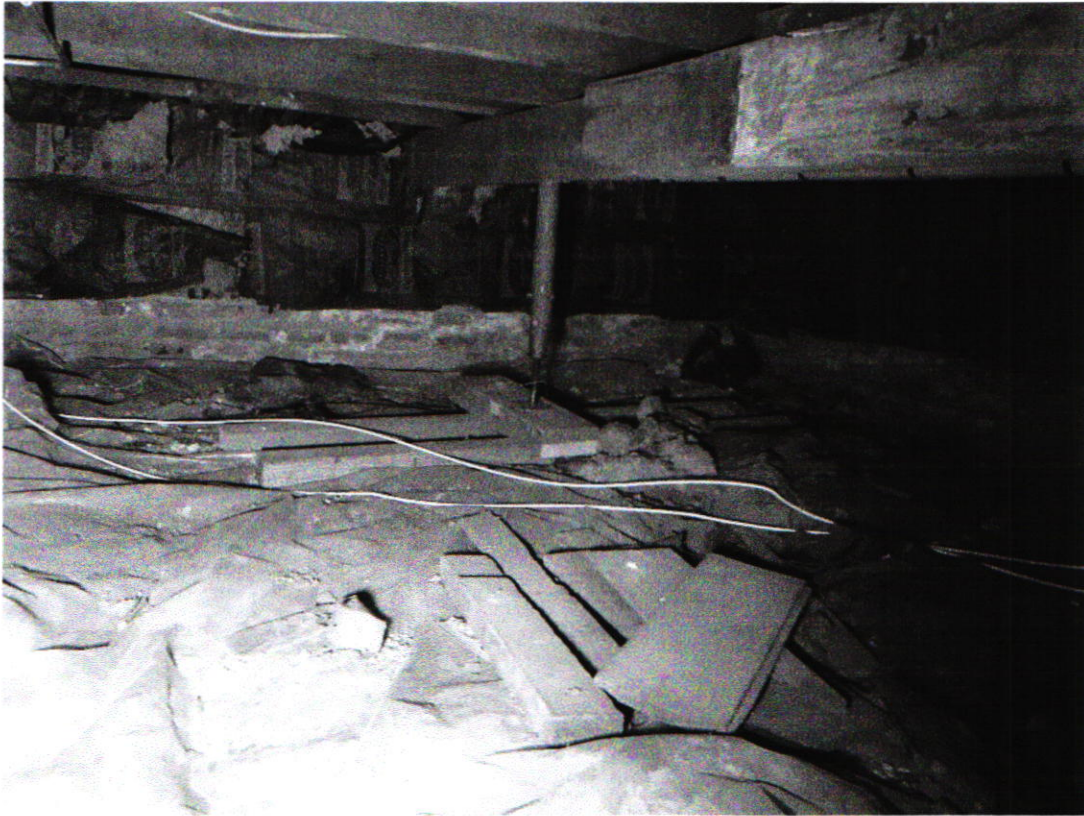
Photograph #5 - shoring below front sun porch

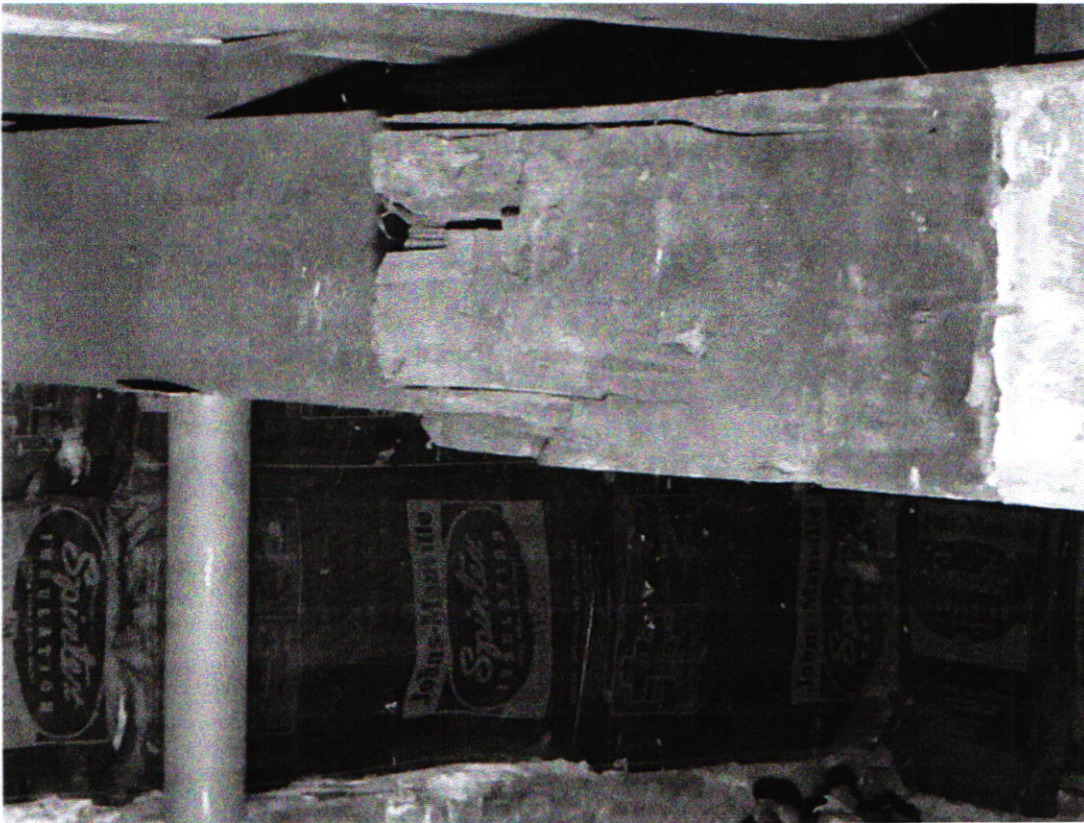
Photograph #6 - unsupported beam end under sun porch

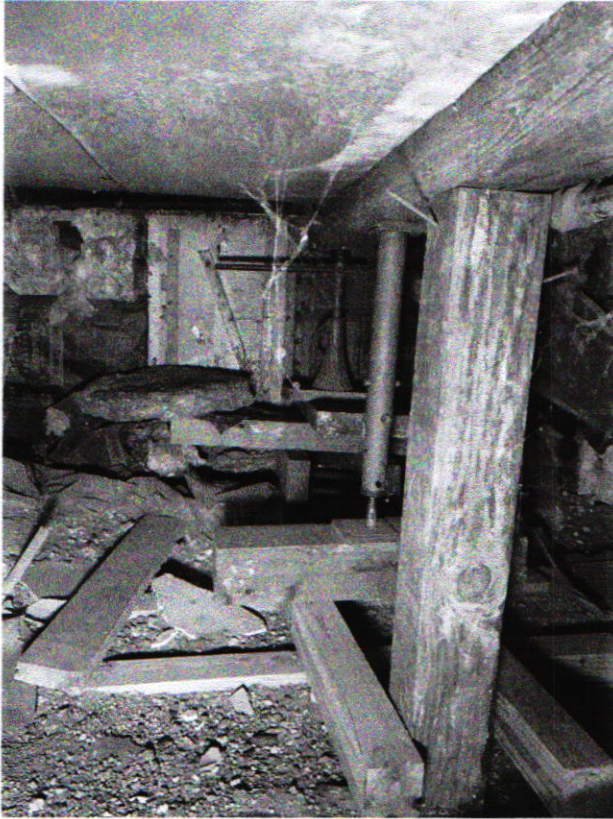
The southeast corner of the building was also originally constructed as a porch. As is the case with the front sun porch, this area was enclosed at some point in history. Photograph #7 shows a hodgepodge of posts, screw jacks and blocks which shore up the floor in this area, and Photograph #8 shows the outside southeast corner held up by a temporary post and screw jack. The block of stone or concrete at this corner likely only extends a short distance below grade as the floor in the both the first and second floor rooms above this area slope almost 3" in 10 feet. Photograph #9 showing the wall of the second floor room above is evidence of how much this corner has dropped.

Photograph #7 - shoring & posts below southeast corner area

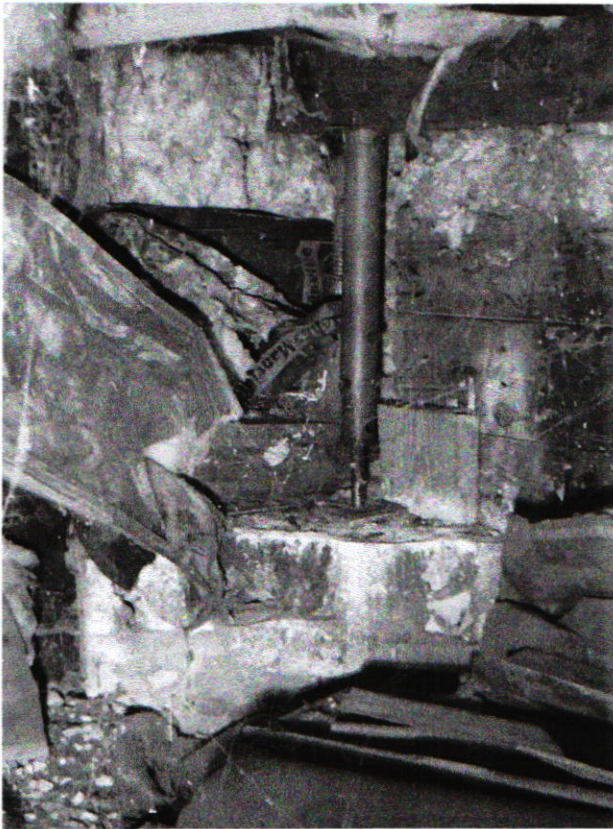
Photograph #8 - support at southeast corner of building

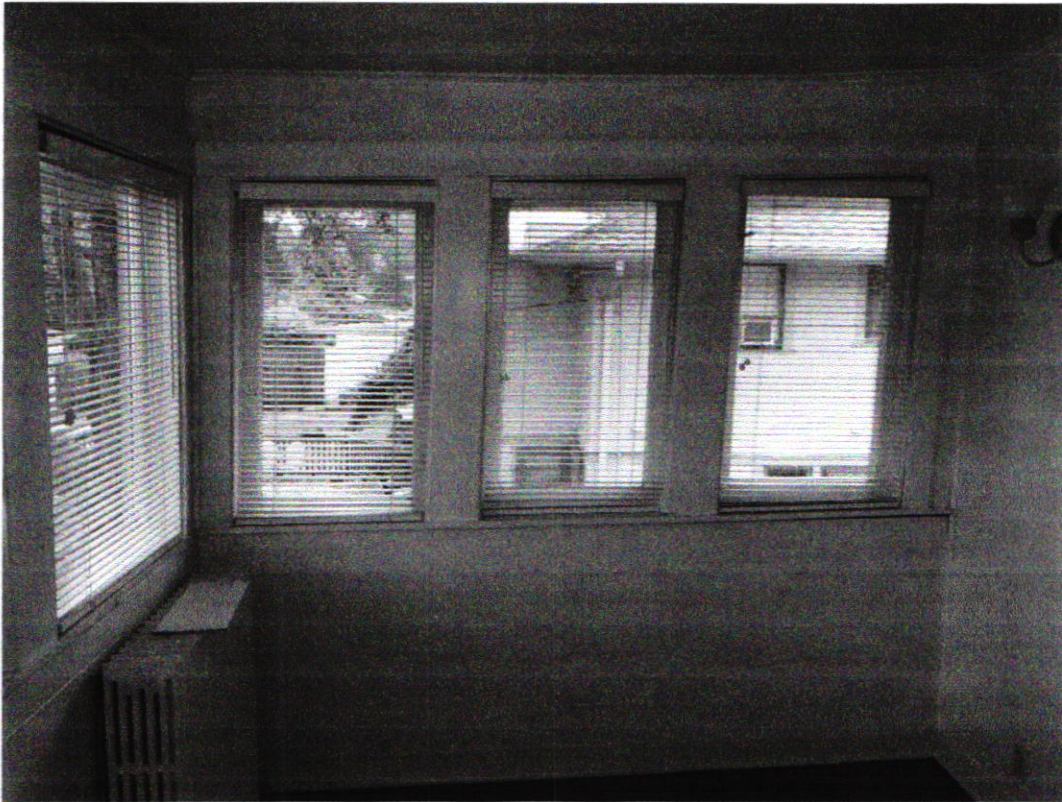
Photograph #9 - south exterior wall above shored area in southeast corner

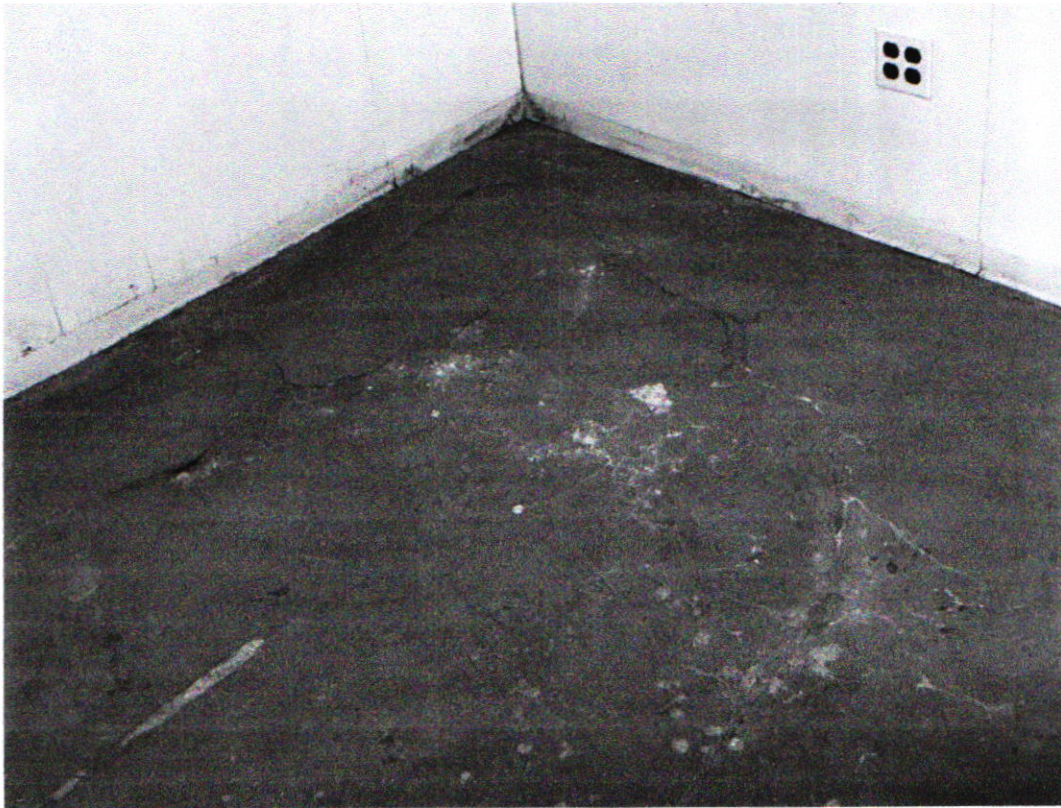
Throughout the basement, the floor slab has cracked and heaved significantly. Having seen this at other projects, this generally occurs from a combination of ground water pressure on the underside of the slab and lateral displacement of the foundations. (Photographs #10 and #11) Given the cracking and tipping of the walls in the portions of the basement where the foundations have not been concealed, I suspect that there must have been a substantial

amount of movement in the northwest corner of the building as the floor in that corner has lifted up as much as 2-3/4" at a portion of the floor.

Photograph #10 - heaved floor slab in northwest corner of basement

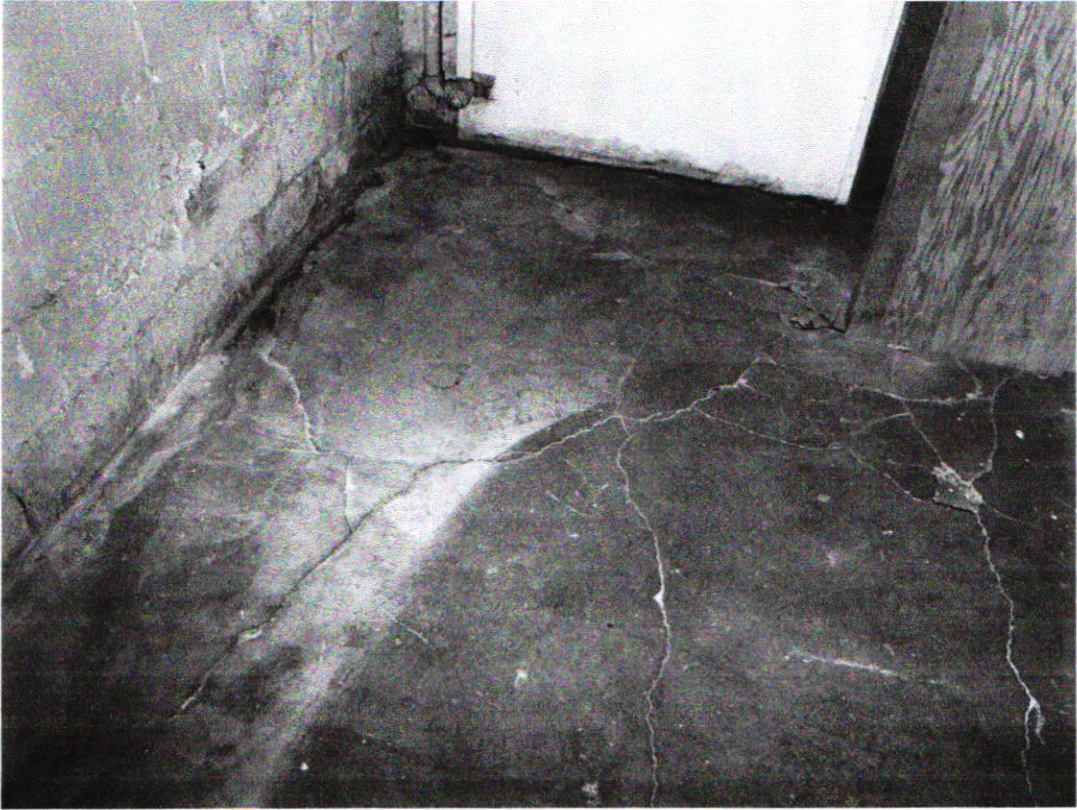
Photograph #11 - heaved floor slab in southeast corner of basement
